Case History

The National Environmental Journal

Protecting Plastic Media with Fiberglass Grating

Dan Guy
Chemgrate Corporation

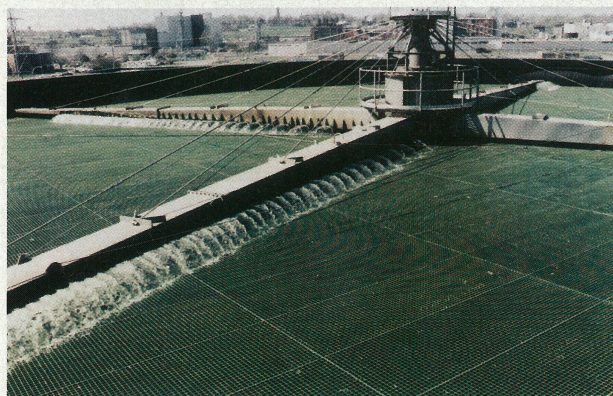
However, about six months after the plant was up and running, engineering personnel noticed erosion on the plastic media's top layers; extra-heavy loading was believed responsible. The surface area of plastic media atop each trickling tower

Ultimately, the plant was forced to replace approximately 170,000 cubic feet of plastic media along the top 2-foot layer of each filter. But a solution was needed to prevent erosion from destroying the plastic media again. This time, the company's investment was protected by installing a 1-inch thick layer of fiberglass grating between the sprinkler distributor arms (which feed water into the towers) and the plastic media. Fiberglass grating was used because engineers noticed that plastic media located under fiberglass walkways atop the towers remained erosion-free. The plant installed approximately 84,000 square feet of fiberglass grating from the Chemgrate Corporation (Woodinville, Washington) to act as a protective blanket over the plastic media.

Chemgrate's material is composed of 65 percent resin and 35 percent continuous fiberglass strand, which provides excellent corrosion and erosion resistance. This fiberglass grating was specifically designed to provide safe, long-lasting flooring in environments where chemicals and other corrosive materials attack and destroy metal grating. In addition, it resists rot, fungi, bacterial growth and adverse effects of acids and alkalis.

To date, the plastic media and the fiberglass grating are holding up well, with no deterioration evident.
